# **INVESTIGATION OF WATER LEAKAGE MECHANISM IN THE KARSTIC DAM SITE, SAMANALAWEWA, SRI LANKA**

A Dissertation submitted in partial fulfilment of  
the requirements for the  
Degree of Doctor of Philosophy

Department of Engineering Systems and Technology  
Graduate School of Science and Engineering  
Saga University  
Saga, Japan

**September 2007**

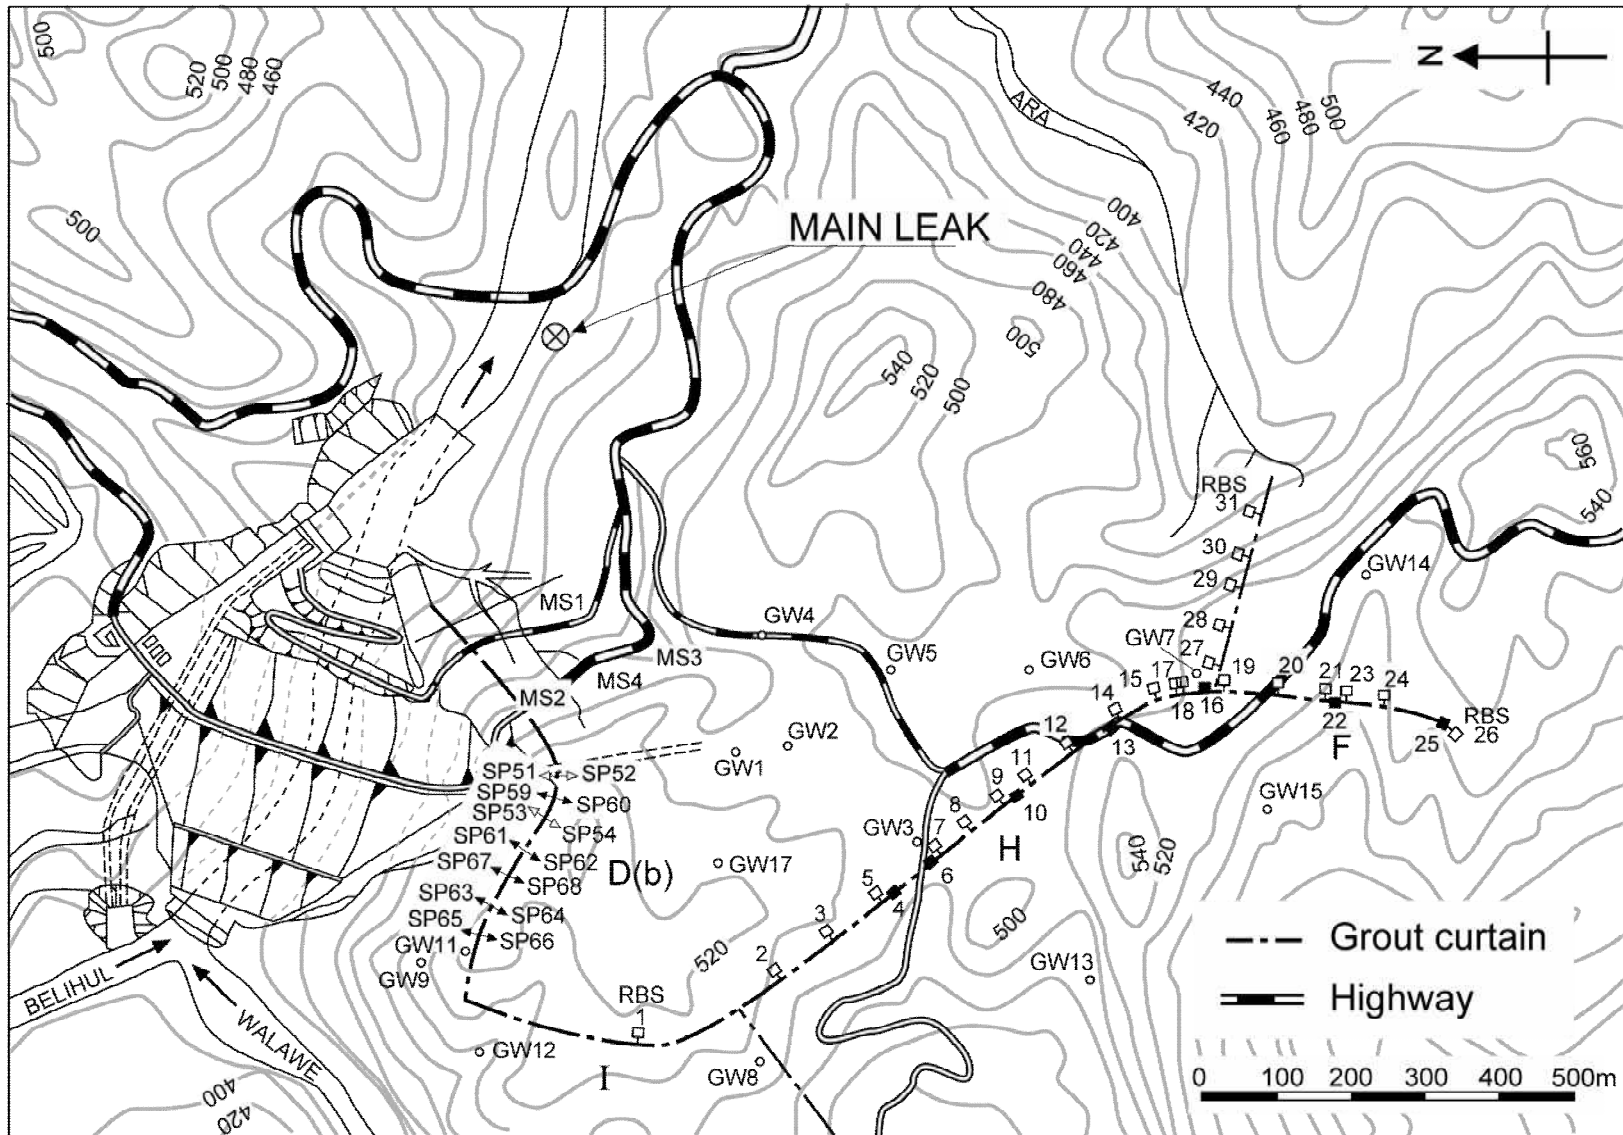
**Figure 1.3** Plan view of the grout curtain

This burst also resulted in a sudden drop of ground water level shown by the majority of the observation wells and piezometers. All those observation wells and piezometers which were showing an equal ground water level, indicated a 25 m drop instantly and then stabilized at a level about 10 m below the reservoir water level after about 10 hours . The leakage flow rate and ground water level behaviour during the burst are discussed in detail else where. Further since this incident the total leakage flow is emanating from a single outlet, which is an opening of a karstic cavity or channel (marked as main leak in Figure 1.3), lying at the base of the crater (ground elevation 392 m amsl) created by the burst.

As a remedial measure, construction of a grout curtain was decided as the best solution to seal off the leakage. Thus based on the additional geological investigation results a 100m deep 1315 m long grout curtain was designed with the aim of cutting off the main leakage paths passing across the right bank. According to the geological findings, the potential leakage paths were considered to be along the karstic rock units and through major faults existing in the right bank. Thus a 1315 m long and 100 m deep grout curtain cutting across the fault zones and running in to the right bank was constructed. The grout curtain consumed 13,450 tons of cement and involved 53,600 m of drilling for grouting. Average cement consumption was 256 kg per meter depth with a maximum recorded grout take of 15.5 tons/linear meter. A set of grouting adits (marked as D(b), I, H, and F in Figure 1.3) was used in this construction. The Figure 1.3 and 1.4 shows the plan layout and longitudinal cross section respectively of the grout curtain. The Table 1.2 shows the grout takes and drilling involved in the grout curtain construction.

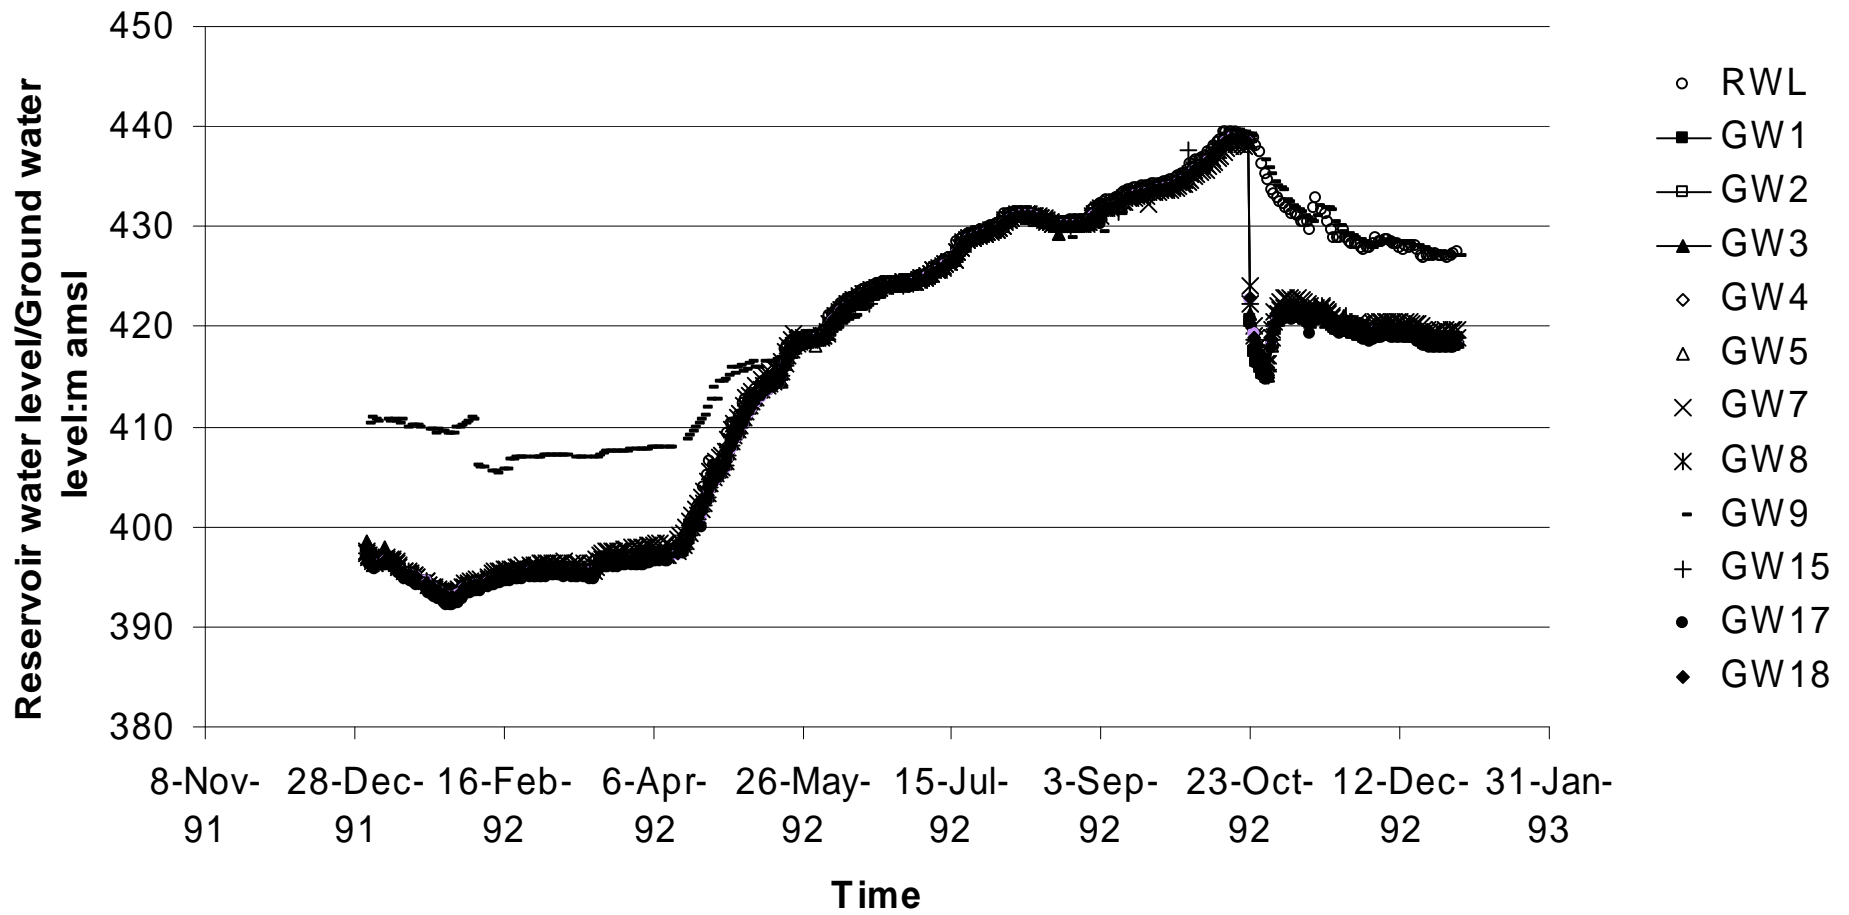
**Figure 4.3** Right bank ground water level variation over time of GW and MS series observation wells during second impounding

The above denoted GW, MS, RI and B observation wells and RBS piezometers are located on the right bank while the SP piezometers are on the dam right abutment. As observed in these figures except few observation wells and piezometers the majority of observation wells and piezometers located through out the right bank and in the abutment, behave in a very similar manner, indicating the porousness of the right bank . This will be discussed in detail later.

The Figures 4.3, 4.5 and 4.6 presented previously show how the right bank ground water level behaved during this incident as exhibited by the different observation wells and piezometers.

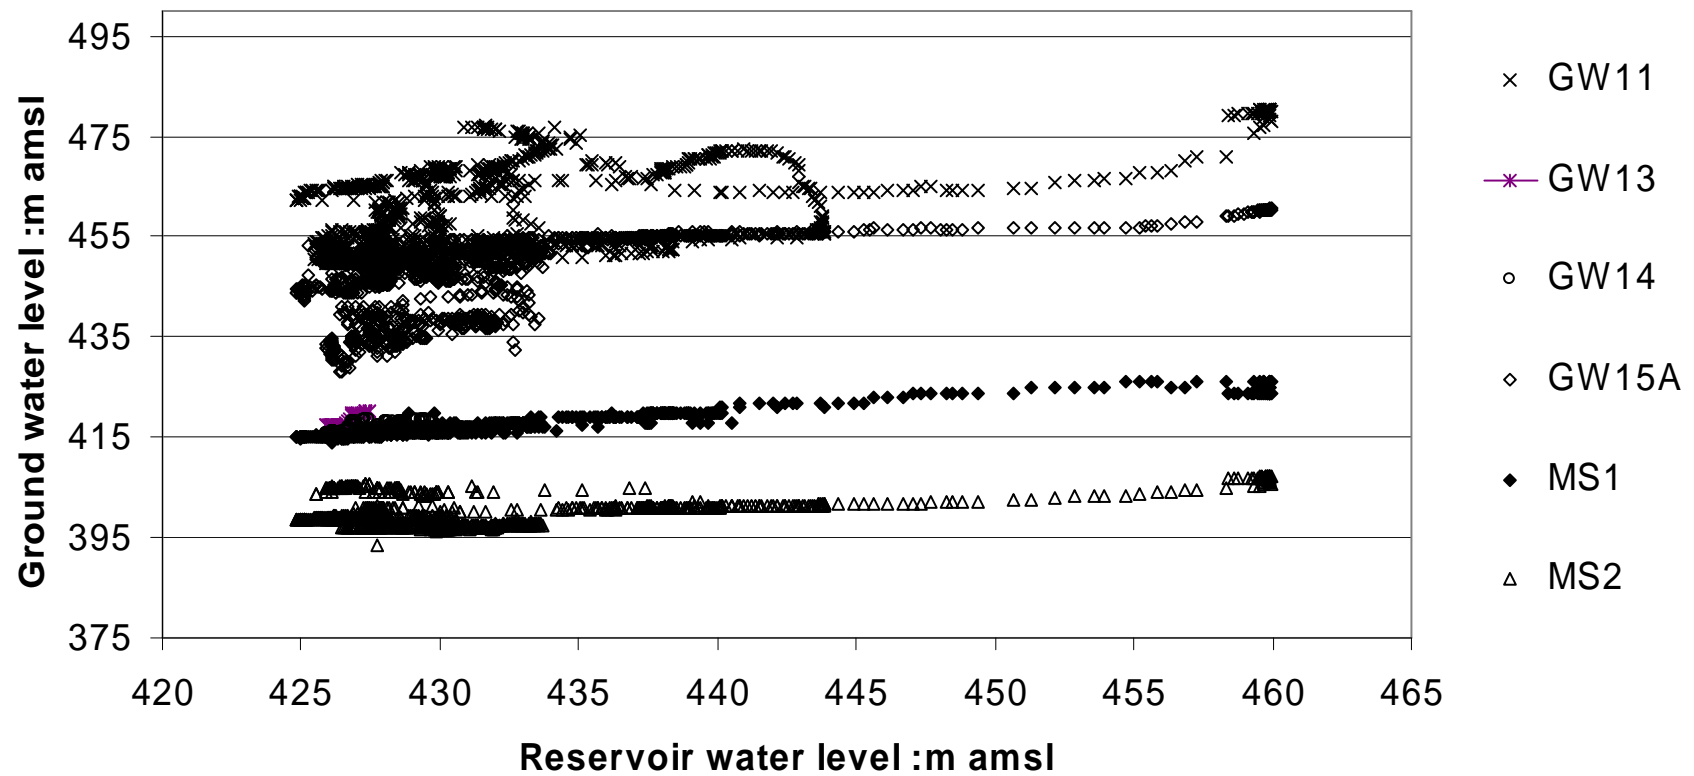
**Figure 4.10** Ground water level – reservoir water behaviour of the observation wells which indicate perched water table conditions

As observed in the above graphs, majority of observation wells and piezometers exhibit a similar behaviour pattern with respect to the changes in the reservoir water level. The few observation wells and piezometers which were behaving independently indicate perched water table conditions. The Figure 4.10 shows the behaviour shown by them.

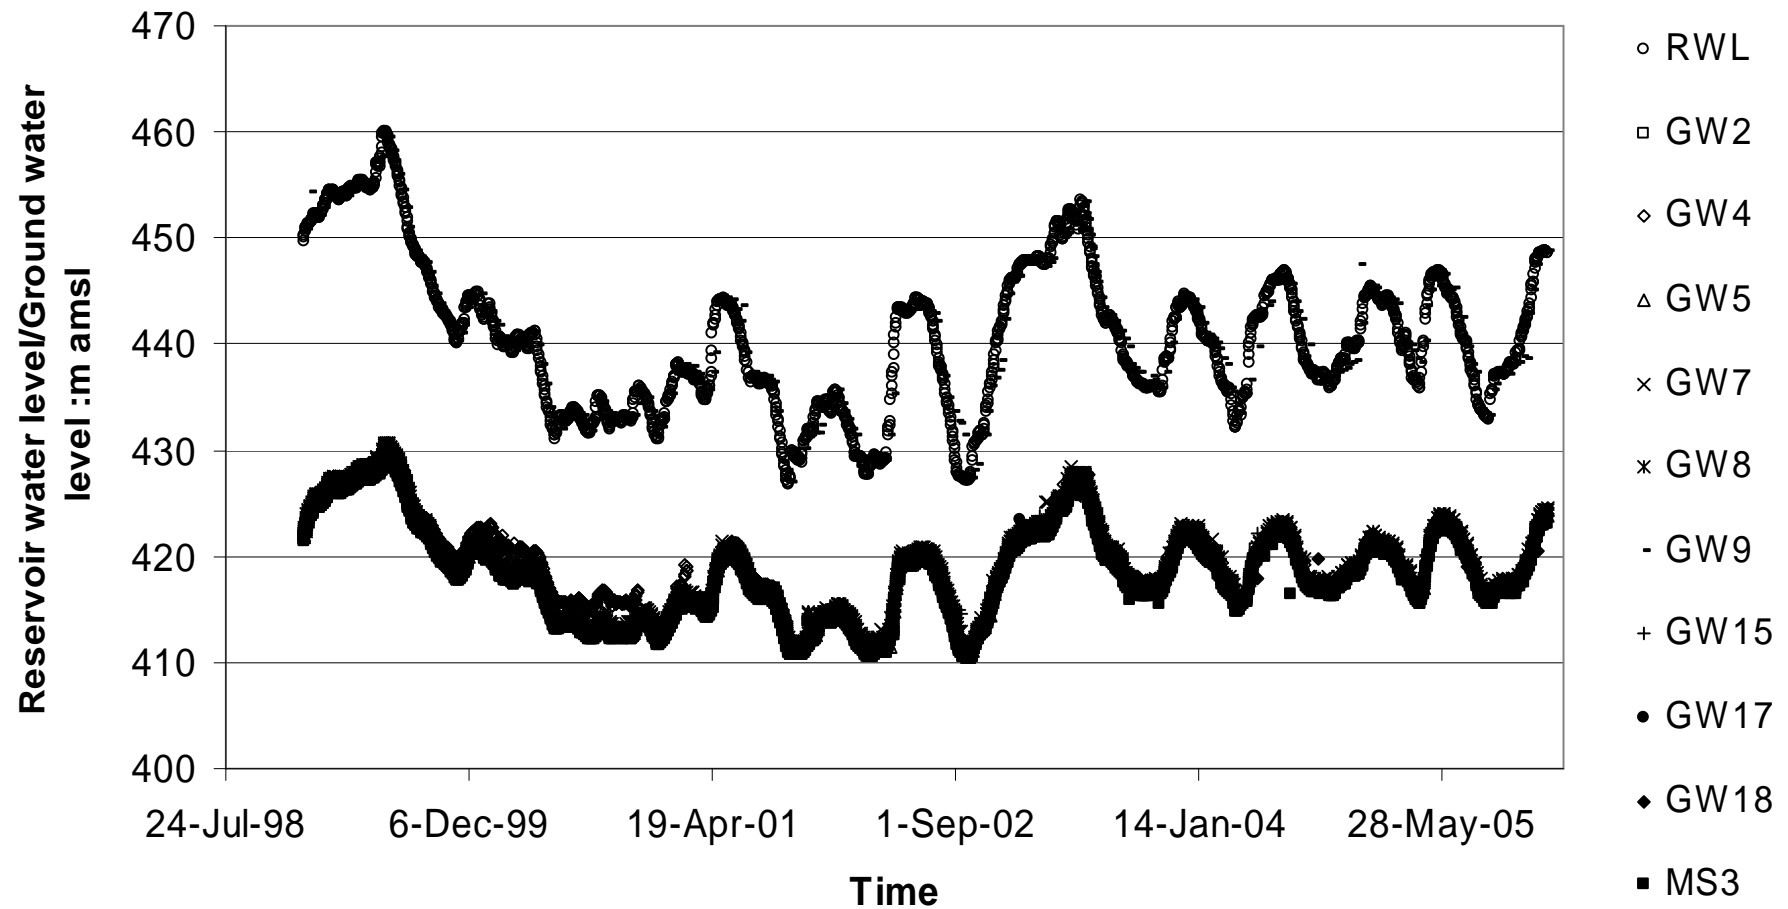
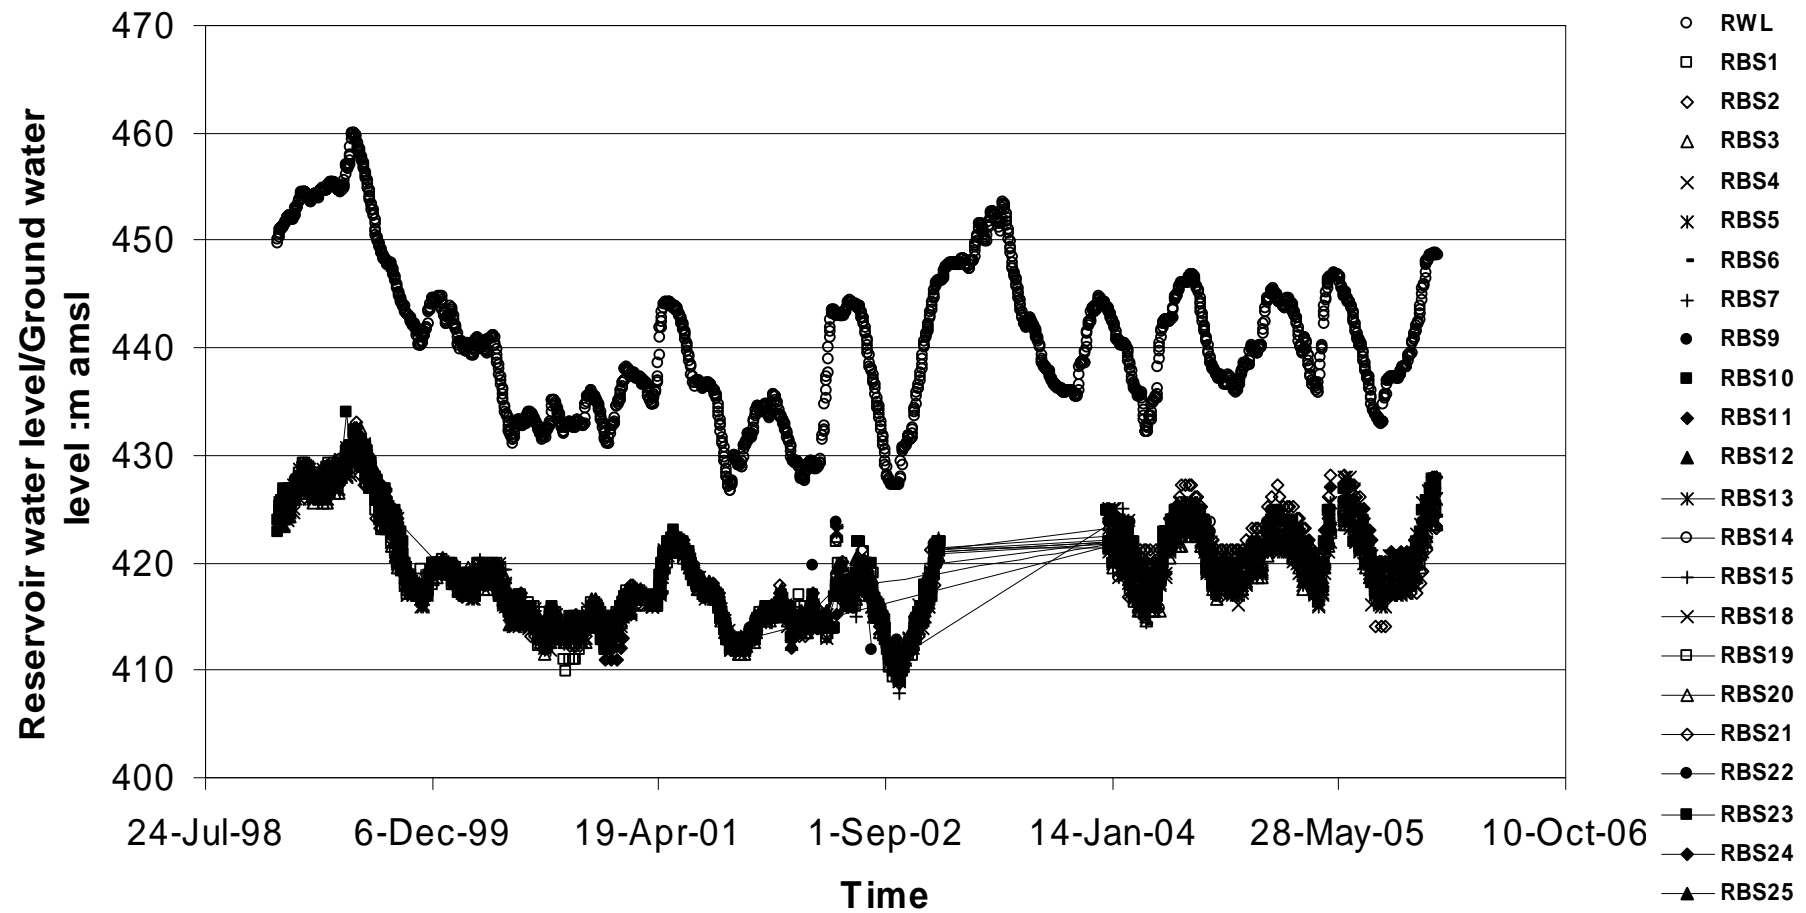
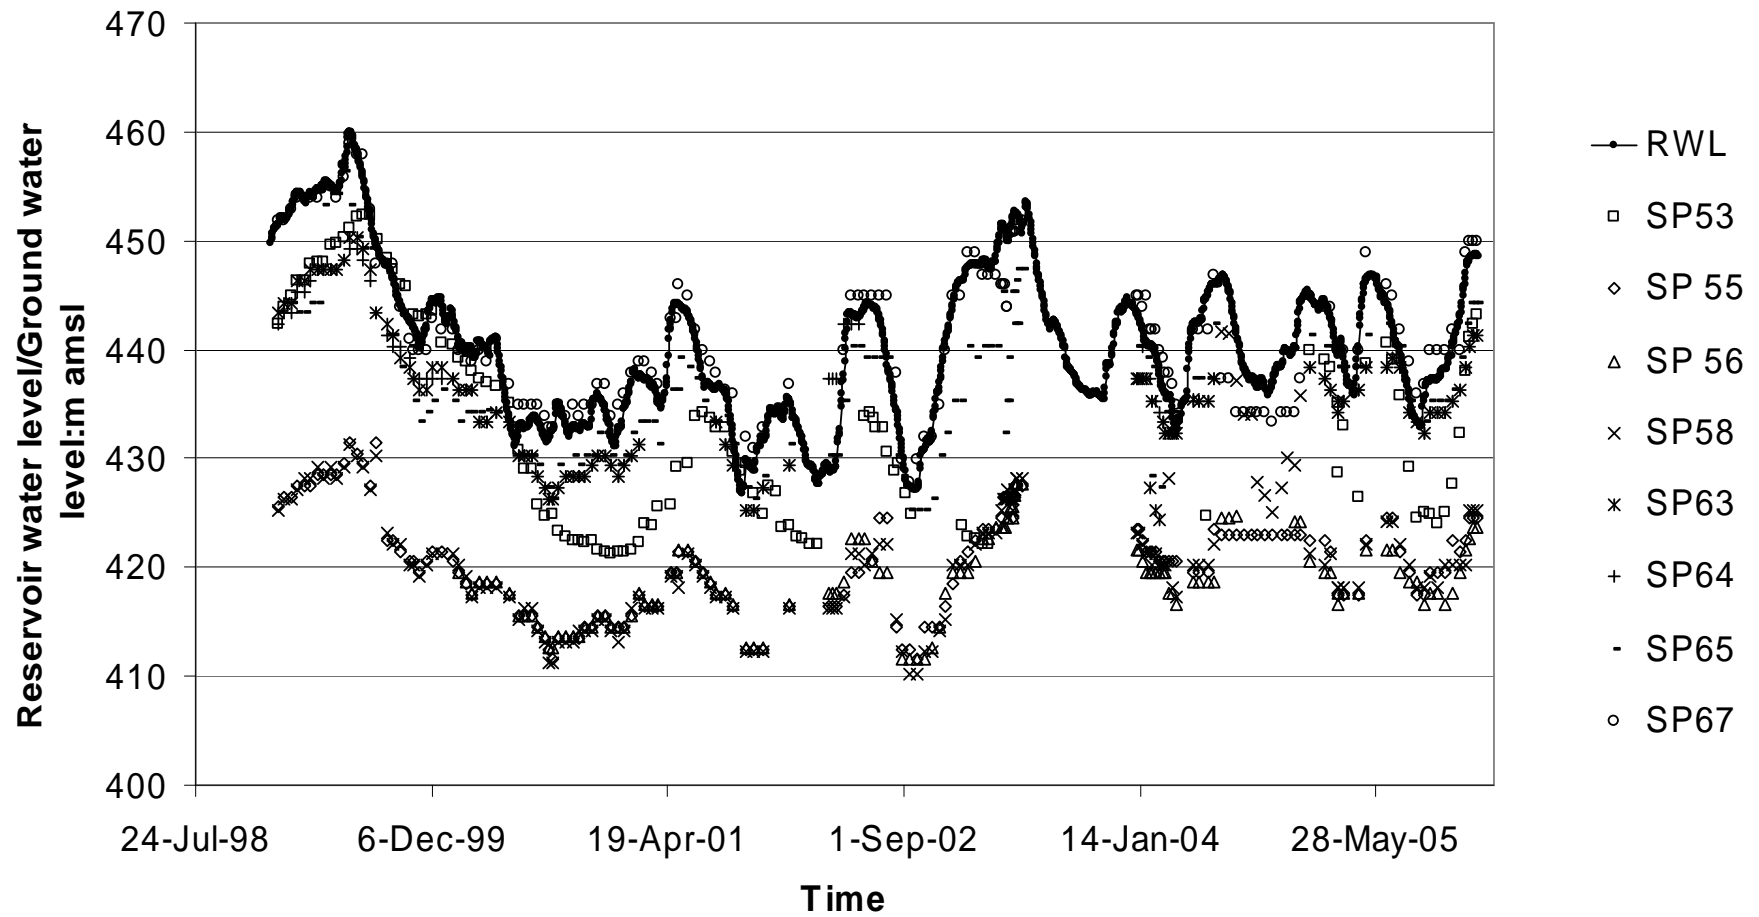
As the above figures depict majority of the observation wells and standpipe piezometers follow a similar pattern. The variation of the right bank ground water level over time during the period 1999 to 2005 is similar to the behaviour observed before the earth blanket construction except the increase in gap with the reservoir water level.

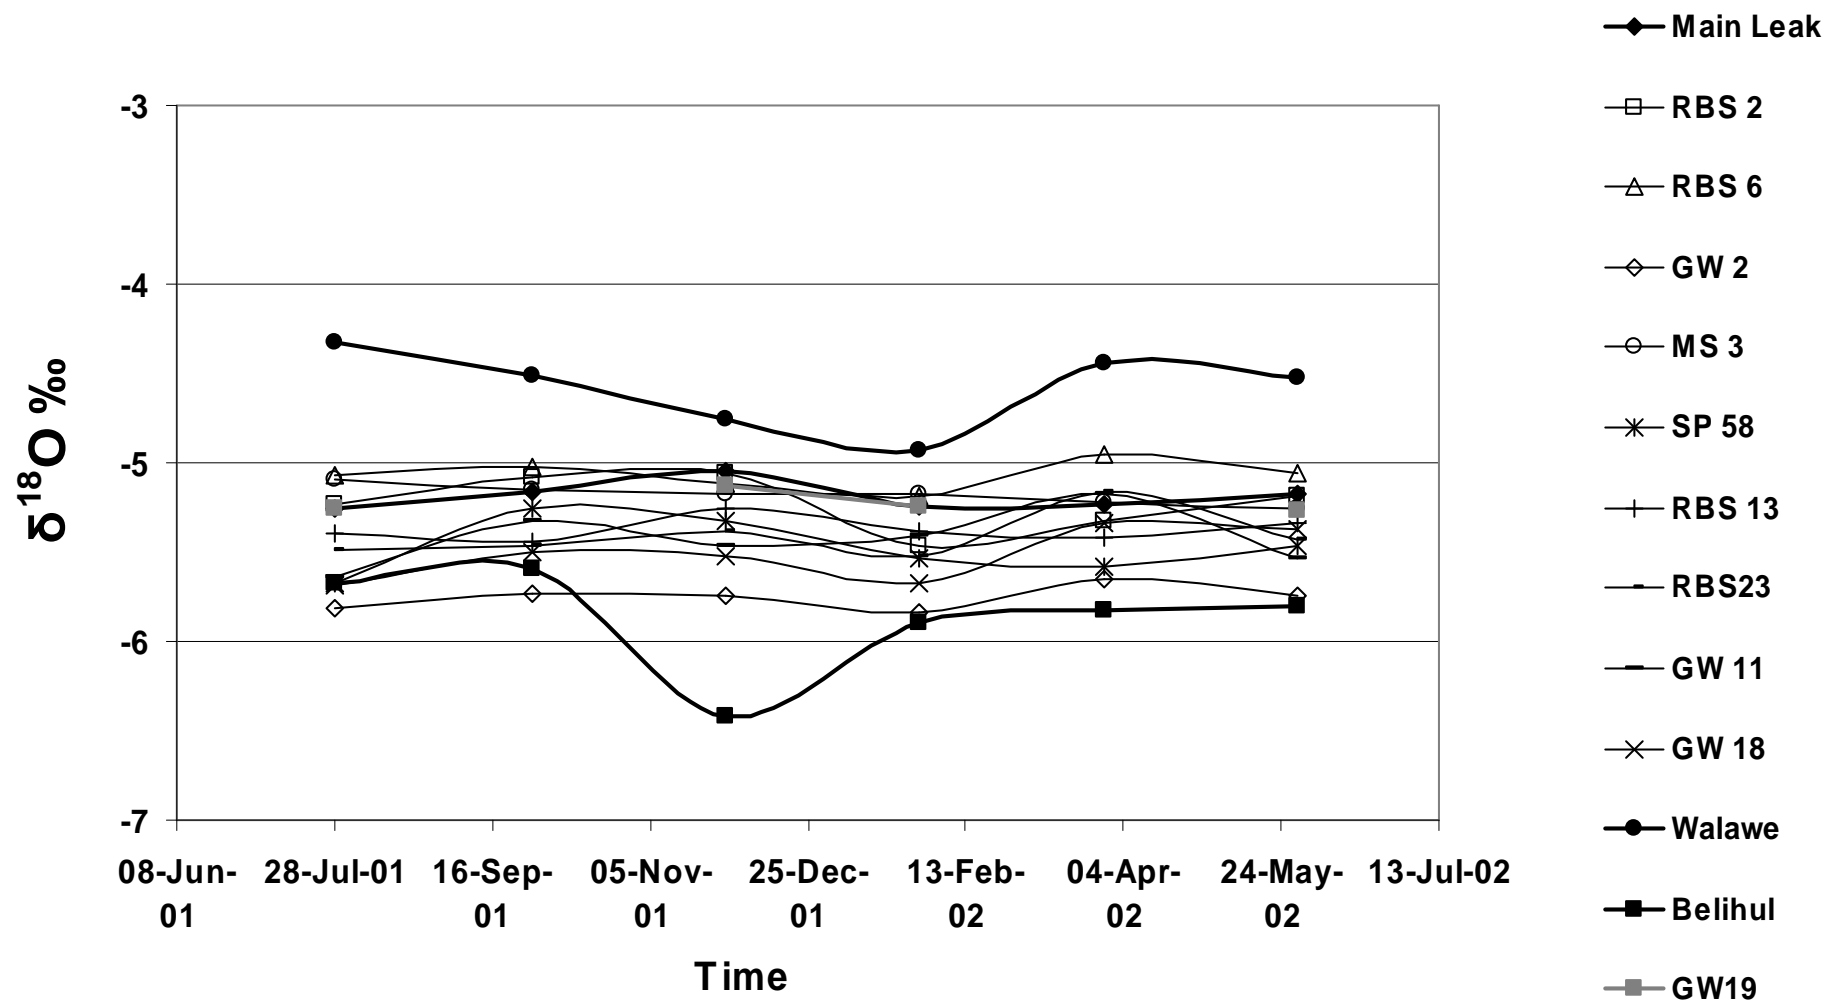
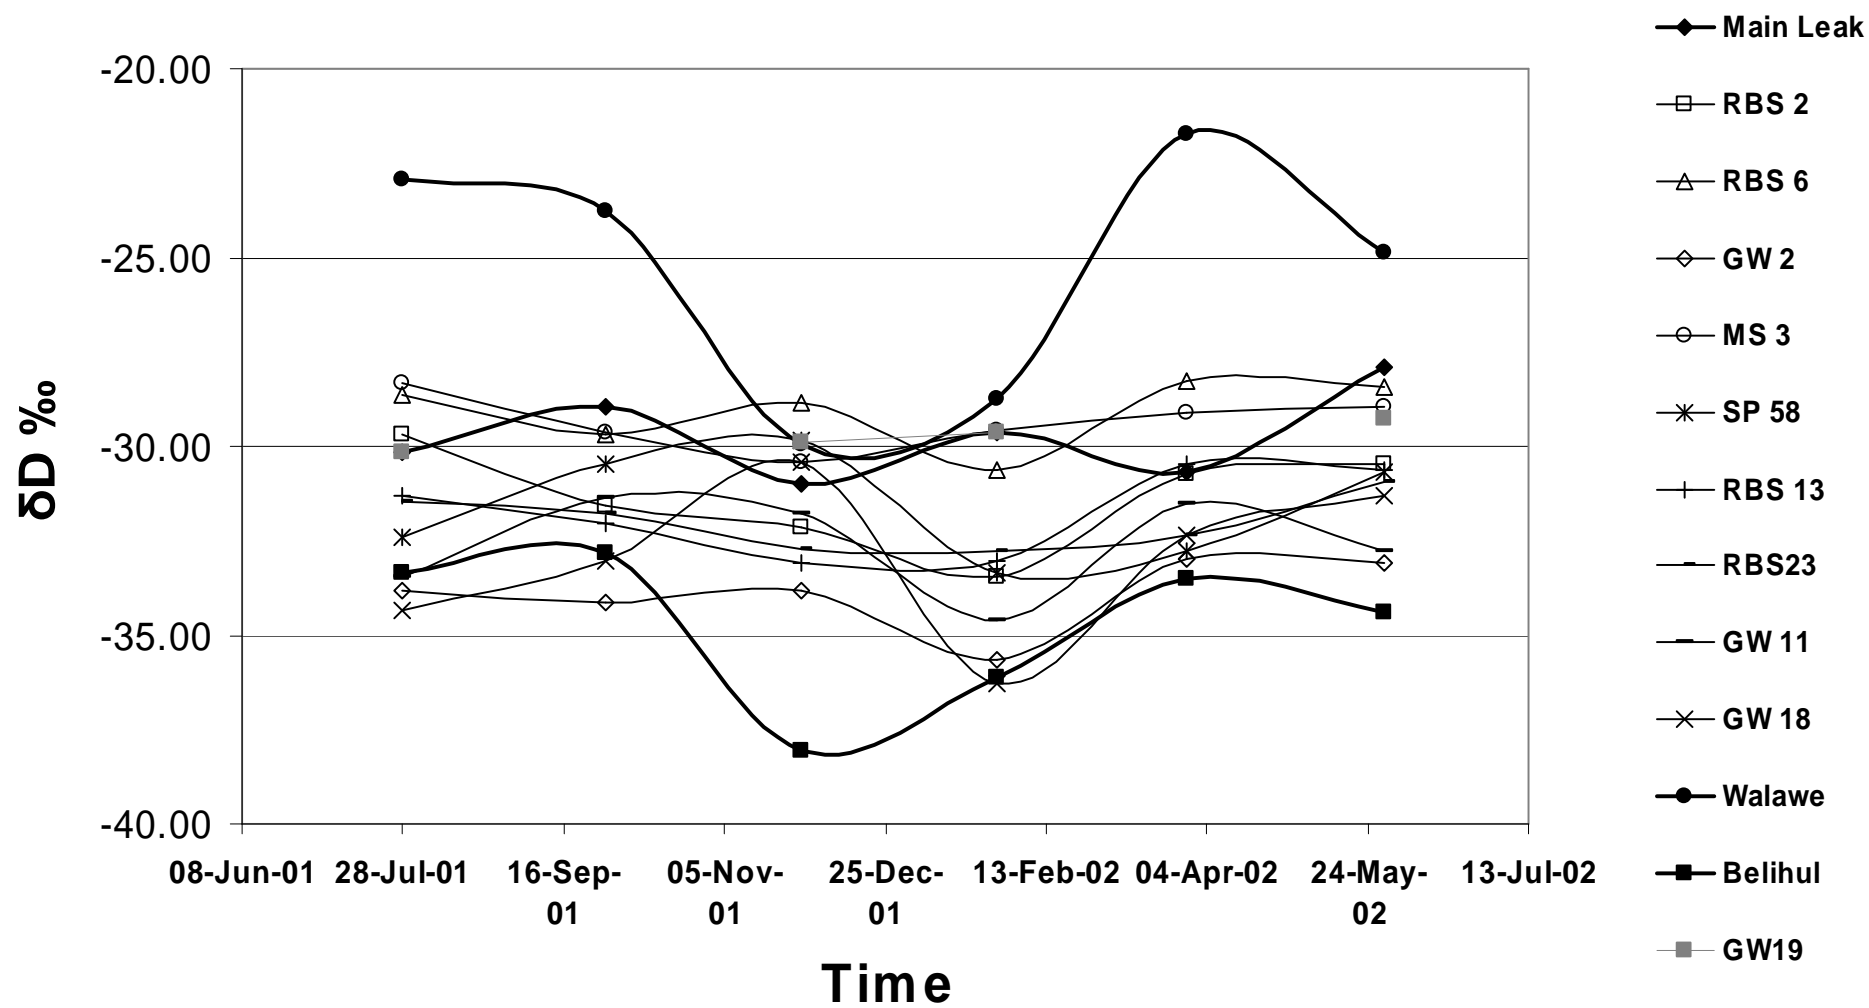
However the following observations could be made. The isotope signatures of the leakage water and most of the ground water wells fall in between that of the two rivers, suggesting that leakage water could be considered as a mixer of waters from the two rivers. Also according to the graphs the leakage water and ground water represent a very similar behaviour with respect to both isotopes. Further it is notable that the isotopic signatures shown by the monitoring wells near the dam and far away from the dam are almost similar indicating an existence of a wide spread underground aquifer. This is further supported by the fact that all these monitoring wells in the right bank show a flat water table which is fluctuating with the reservoir water level. It is a possibility that the ground water in the aquifer has been replaced by the reservoir water which is a mixer of waters from two rivers. The reservoir water which infiltrate to the right bank aquifer through ingress zones initially got mixed with ground water locally and later has replaced ground water as the leakage outlet continue to discharge from right bank.. Considering the time elapsed between the initial leakage initiation in 1991 and the sampling period 2001 being about 10 years this possibility cannot be ruled out. Further, geologically this area had been subjected to karstification and the under ground cavernous nature prevailing has been confirmed during drilling and grouting operations conducted under remedial measures.

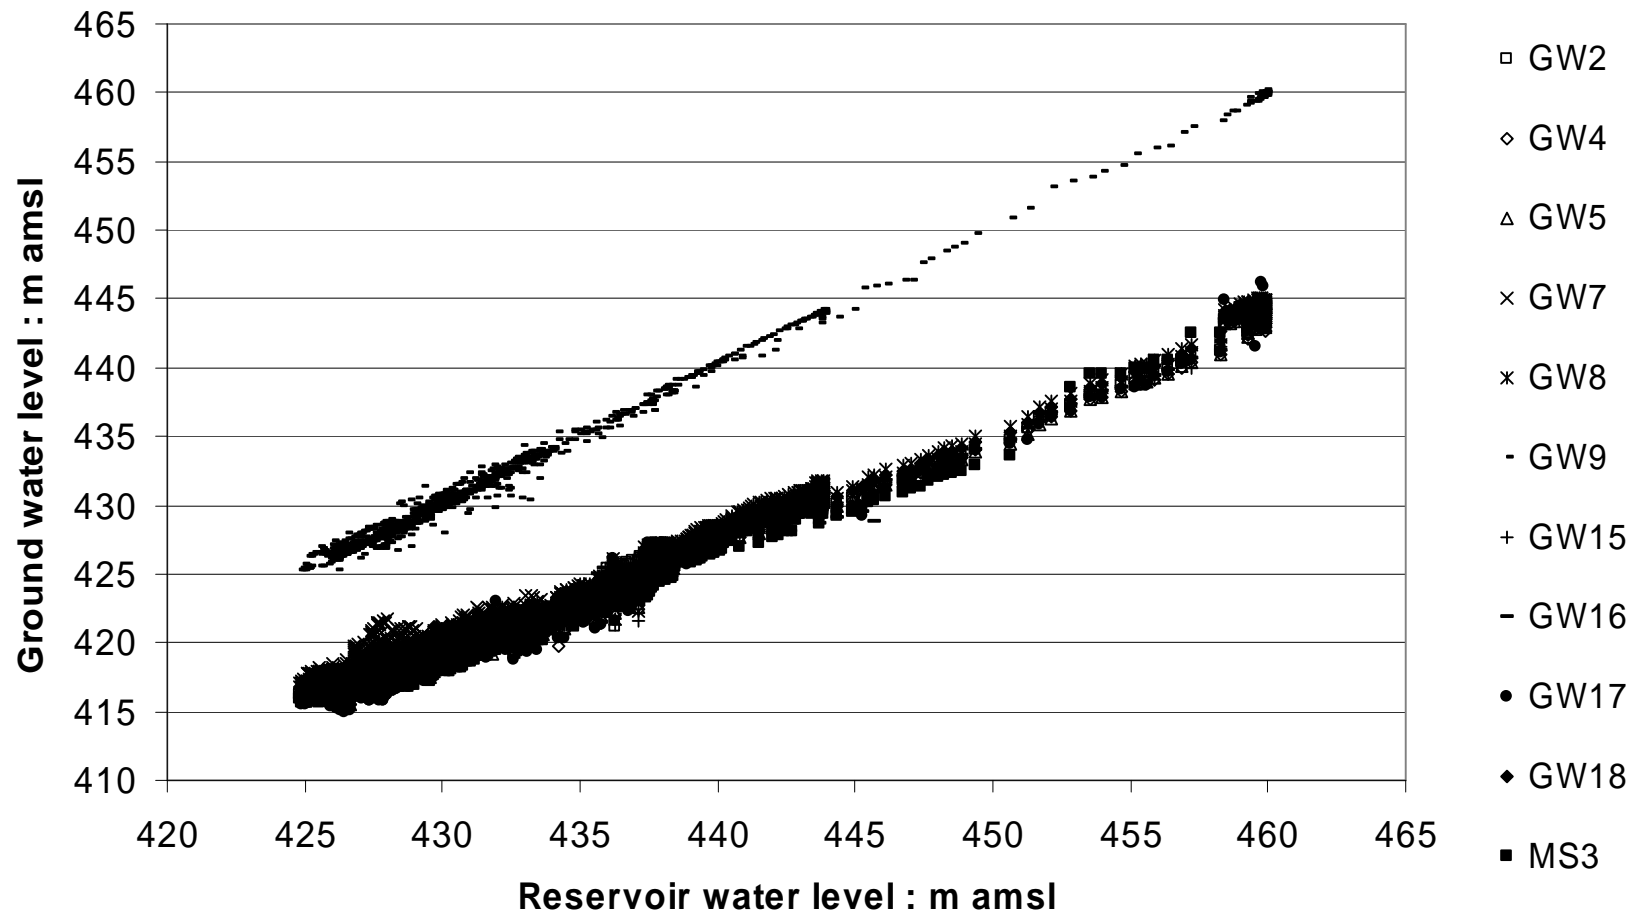
This is common for those observation wells and standpipe piezometers lying close to the dam as well as those installed at the far end of the dam.

**Figure 5.1** Ground water level against reservoir water level of GW and MS series observation wells during 1993 - 1997

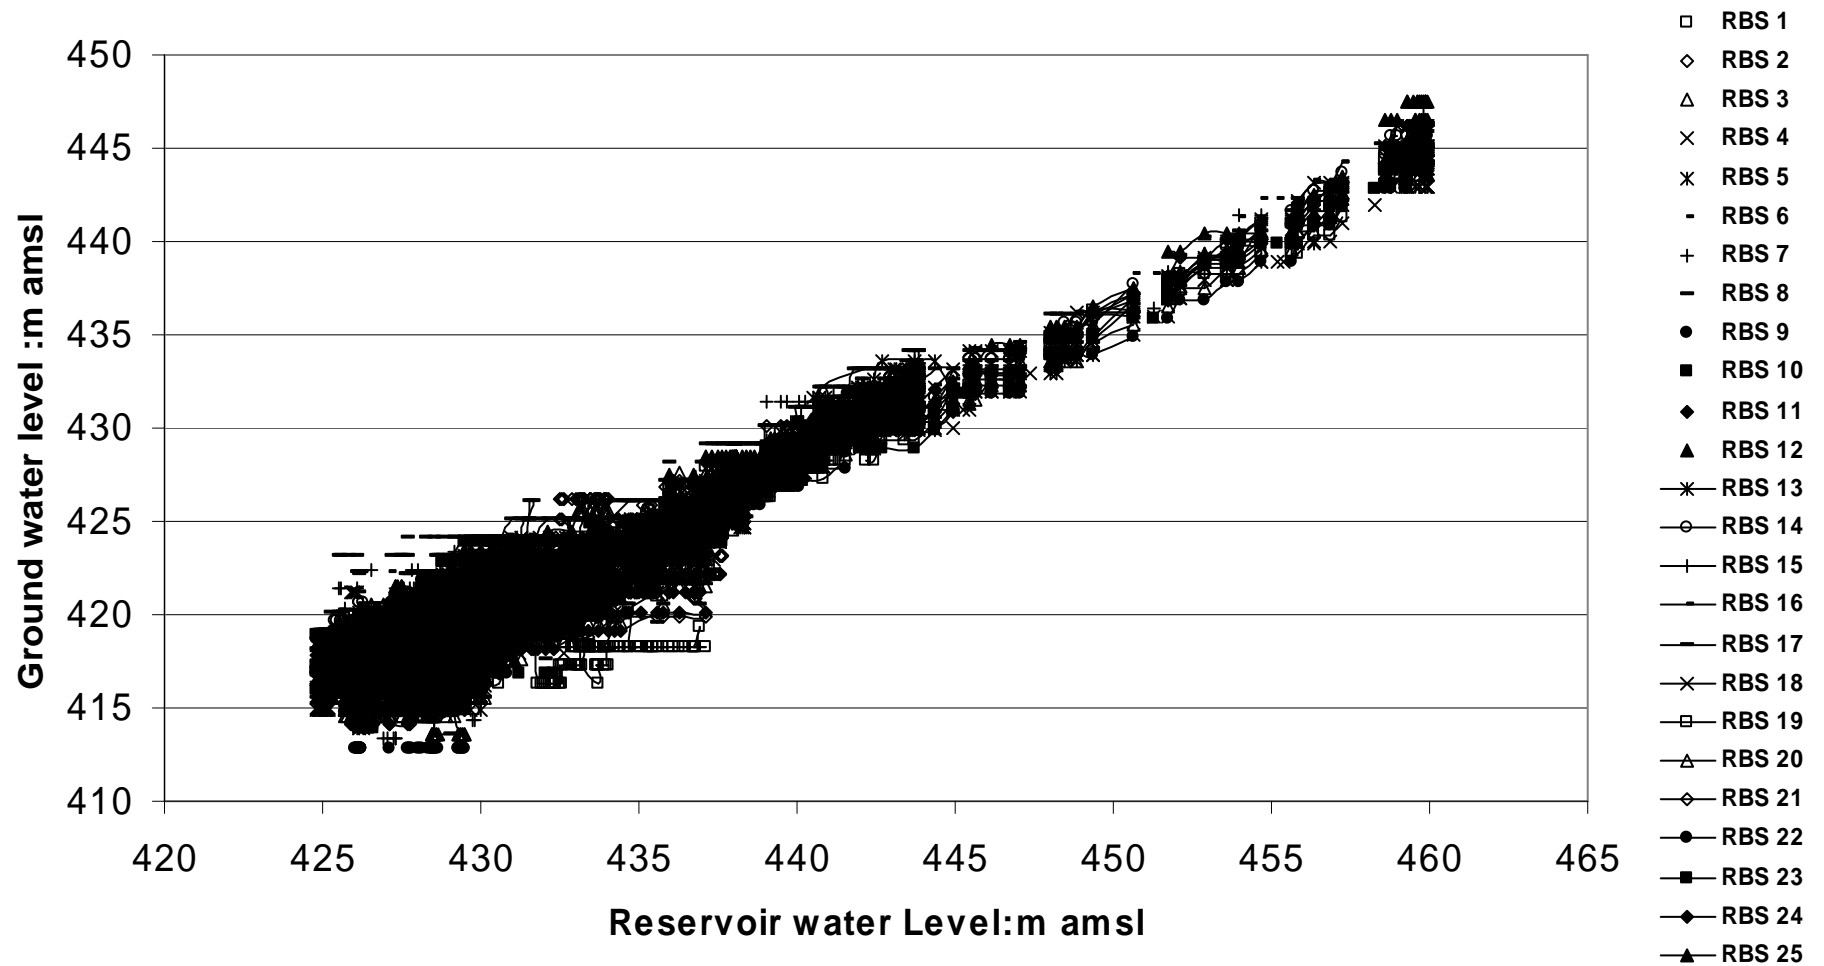
**Figure 5.2** Ground water level against reservoir water level of RBS series piezometers during 1993 - 1997

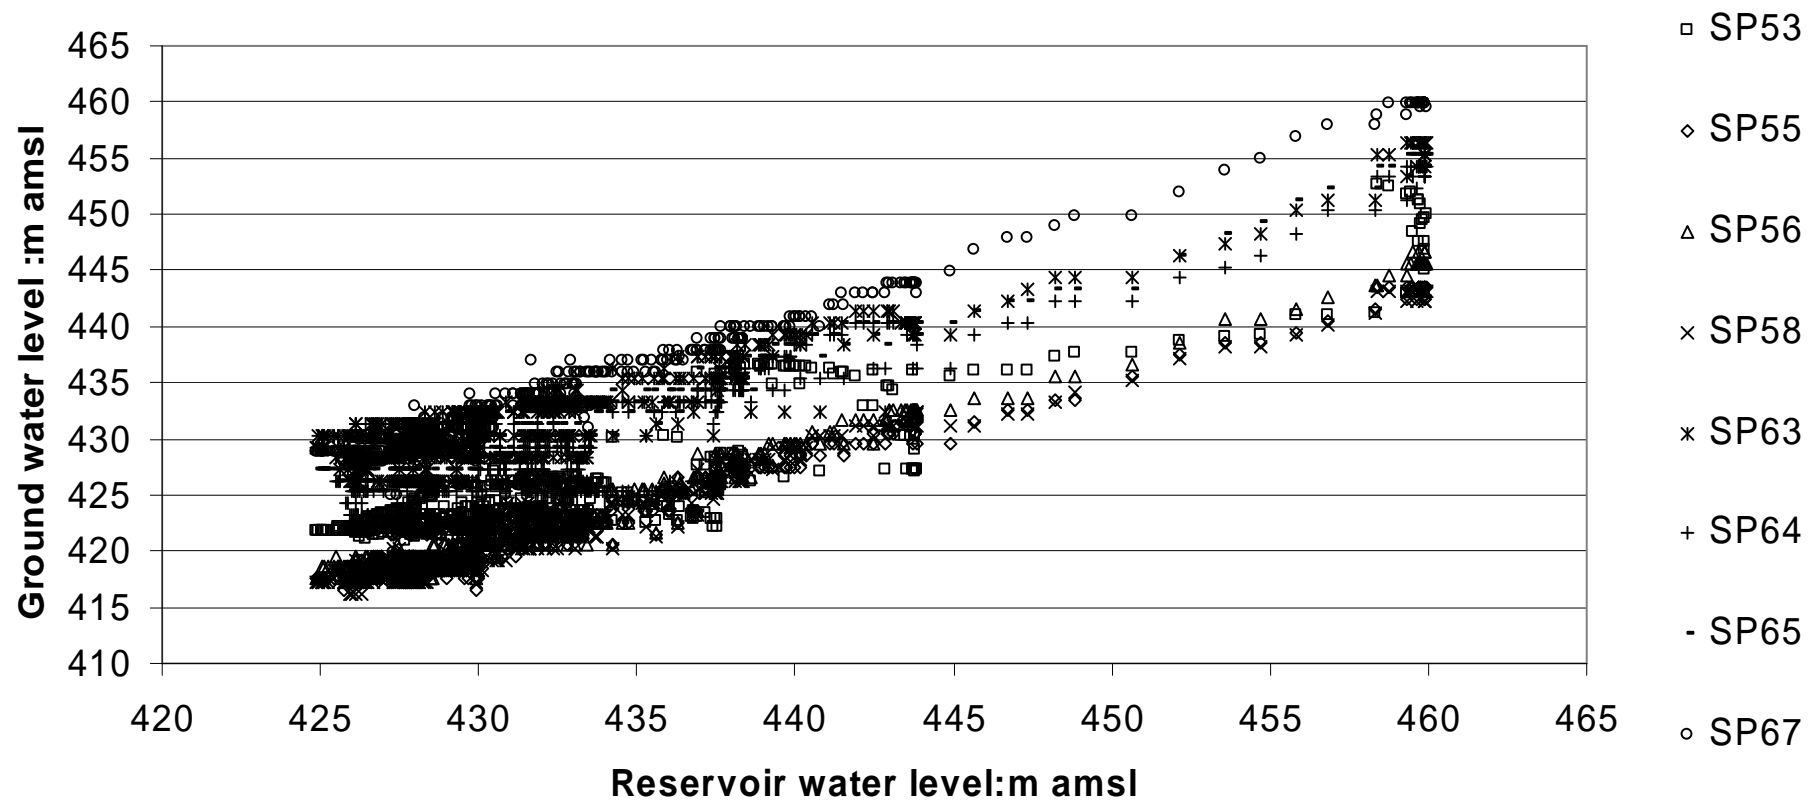
**Figure 5.3** Ground water level against reservoir water level of SP series piezometers during 1993 – 1997

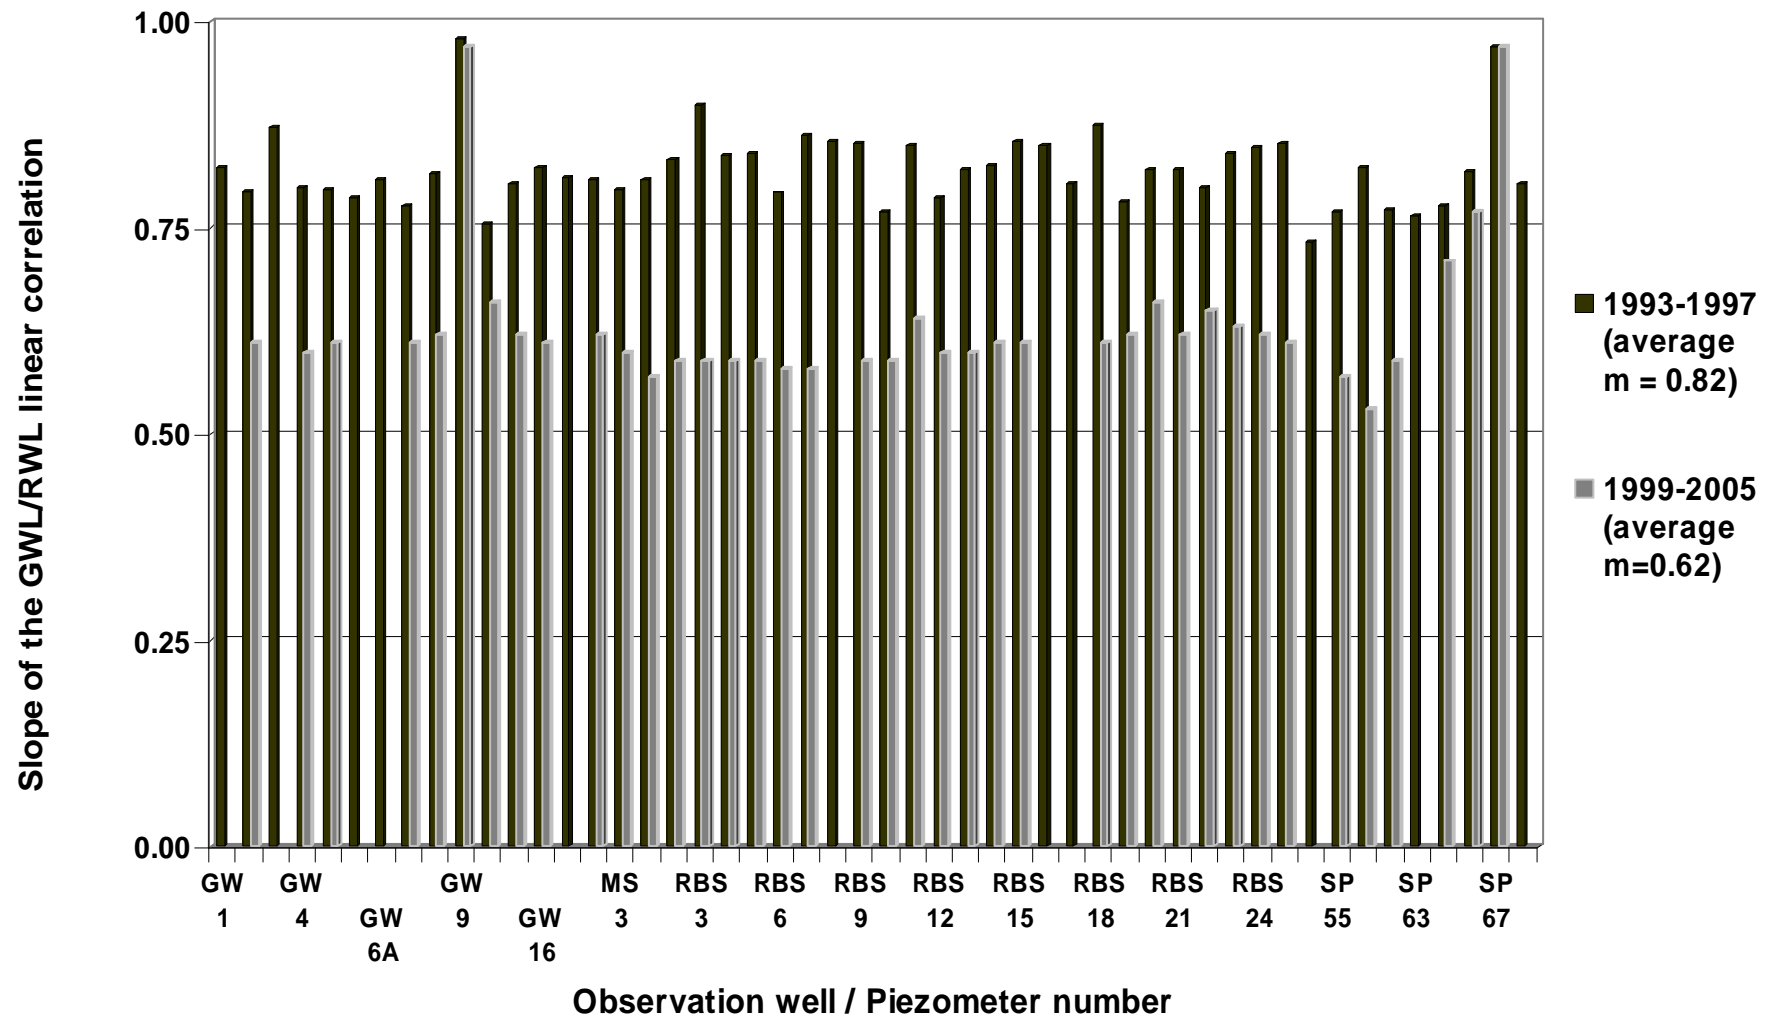
The derived slope values ('m') of all the observation wells and piezometers which are behaving in a similar pattern are presented in Figure 5.4, to emphasize the similarity in behaviour shown by them.

**Figure 5.4** Slope values of the ground water level- reservoir water linear correlation
